FEARN PLANTATION 44PY339 CITY OF DANVILLE, VIRGINIA

PHASE II SIGNIFICANCE ASSESSMENT SURVEY DHR # 2011-0767

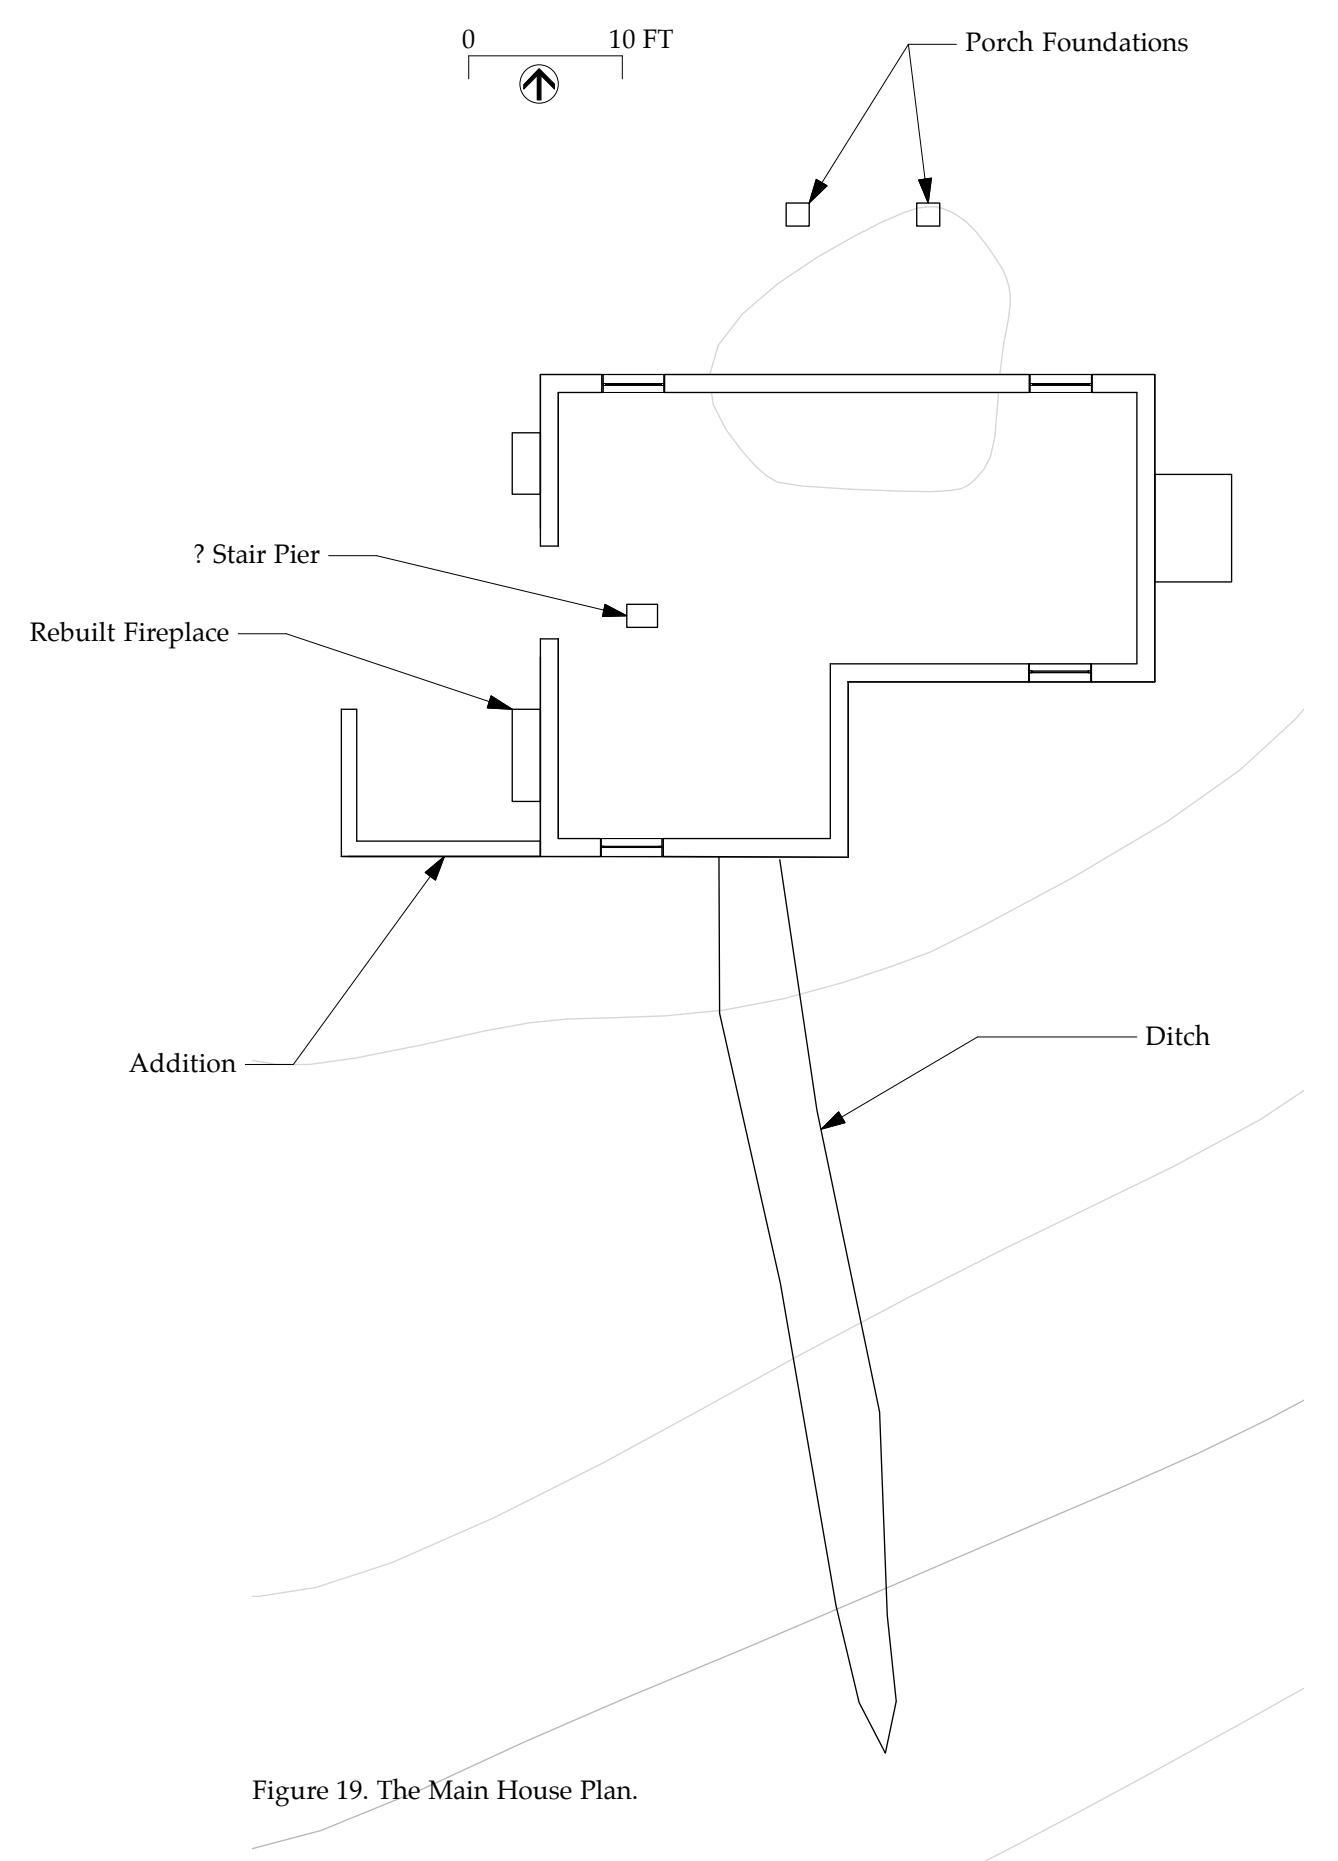
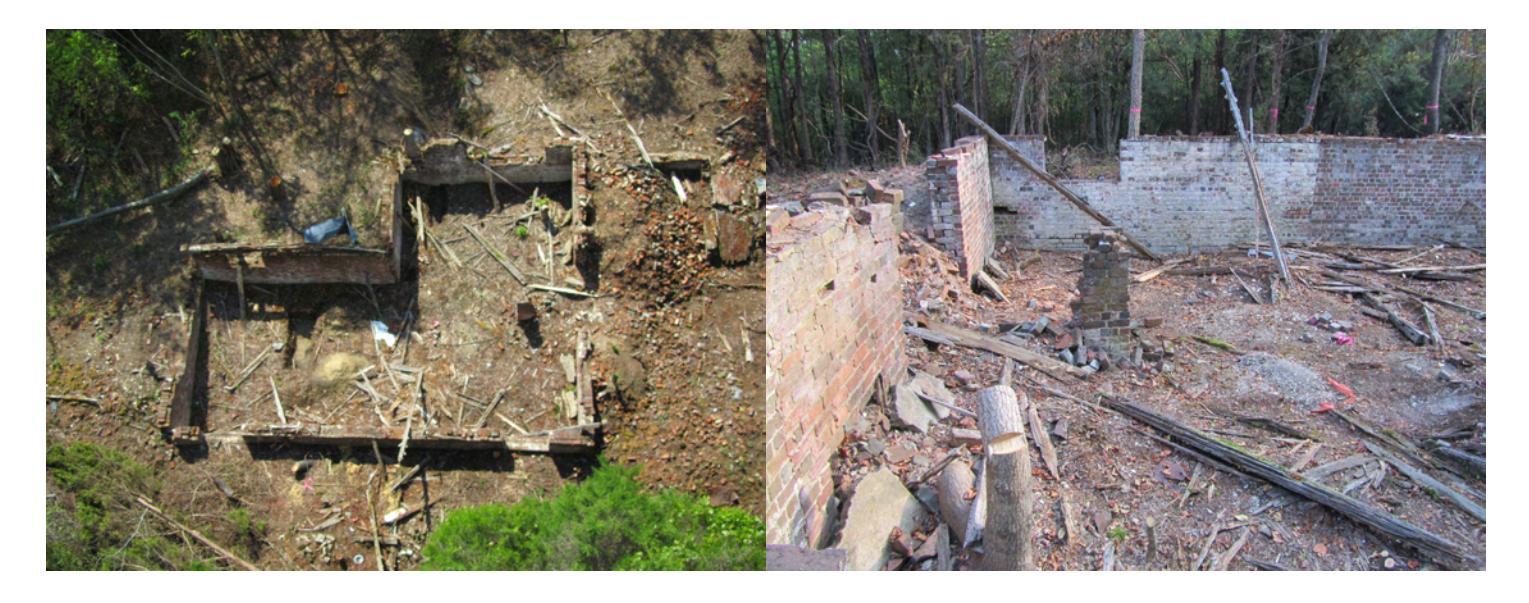
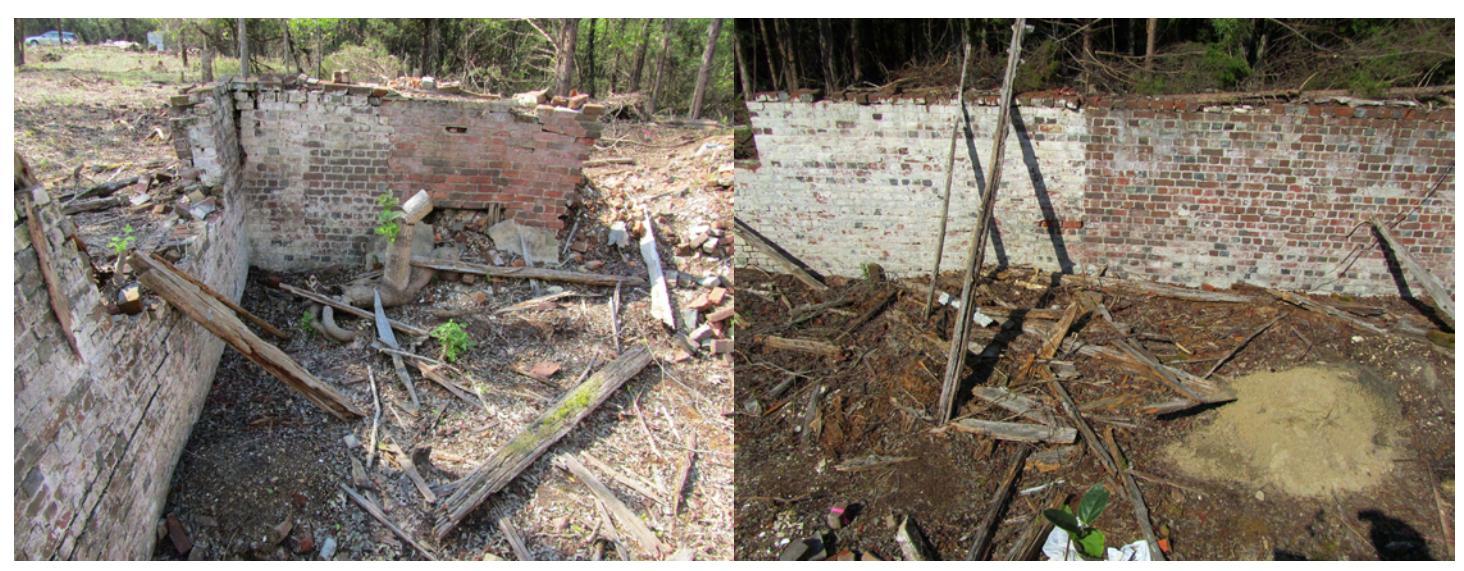
Figure 20. S1, The Main House Photos.

Aerial View of Main House. Bottom of House is North.

Main House Interior, View North Along Ell.

Main House Interior, View To Rebuilt Chimney.

Main House Interior, Center North Wall.

The Fearn House is an L-shaped structure with an English basement. The building foundation was built using English Bond form-made brick. An addition to the west is evident by the abutting to the west wall of the main structure at the southwest corner. In addition to the main house, there is a 6' diameter stone lined well with a later concrete square cap with 3' square hole. That structure has an addition to the east. A set of structures forms a courtyard around the main house to the south and west. The western wall of the courtyard has a series of structures with a common west wall, culminating at the north in what appears to be a kitchen. Immediately east of the kitchen is another foundation stone pile of undetermined function. All of these are stone founded. Southwest of the compound is a probable slave quarters duplex of massive stone foundations with heart pine single beam footers about 40 feet long. The massive double fireplace has the bottom in stone with the top rebuilt in Common Bond brick. Another probable slave quarter is located north of that. All of the nails observed in the outbuildings were machine cut, apart from the collapsed privy building that had wire nails.

This site had the appearance of having been abandoned and allowed to decay in place. There is no evidence of destruction. But, local history stated that the house was dismantled for re-use at the City Farm in 1972. Visible at the house, compound and slave quarters were flooring and floor beams. These evidently were of little value, probably due to powder post beetle infestation. The relative lack of nails visible on the site was another indication. The barn lacked any wood and the granary had a few remnants of what appeared to be floor beams and floorboards. No structural timbers above floor level were noted at the site.

The English Bond brickwork is complemented by mortise and tenon jointed timber framing. The majority of the nails observed were machine cut and thus postdate about 1785 and pre-date the widespread use of wire nails circa 1875. Of the 535 nails recovered, 38% of the identifiable nails were rosehead nails (n=89), 60% were machine cut nails (n=143), and 2% were 20p wire nails (n=4). Danny Ricketts had obtained some additional rosehead nails in his prior visit to the house site decades ago. Adzes were used on the slave quarters boards rather than sawing for at least one example. A single pine floor plate ran the entire length of the house on both long sides. The house provided most of the rosehead nails. We did not map the distribution of artifacts due to the limited sampling as that is appropriate for an in-depth analysis.

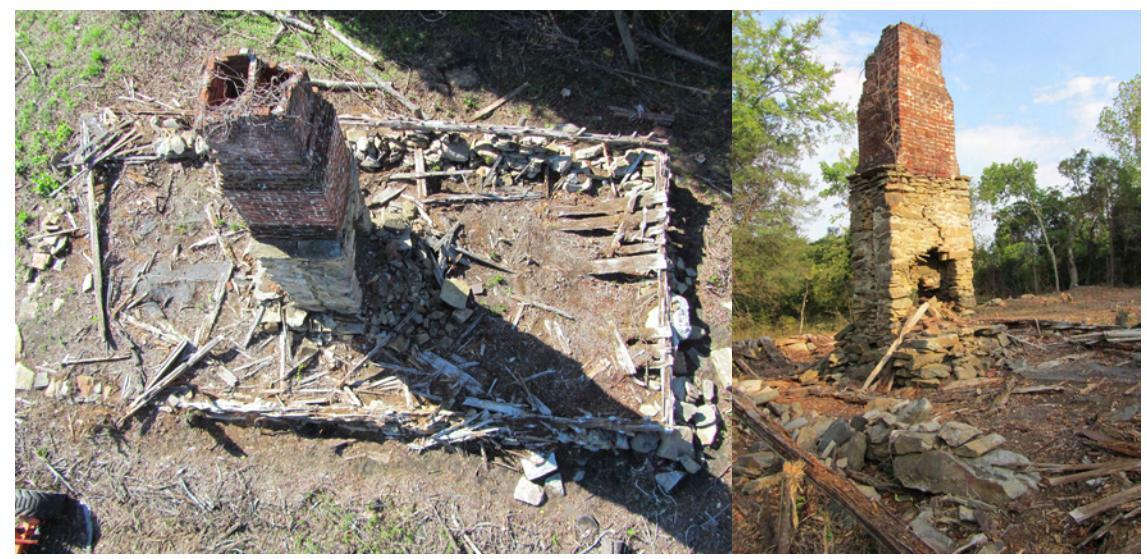
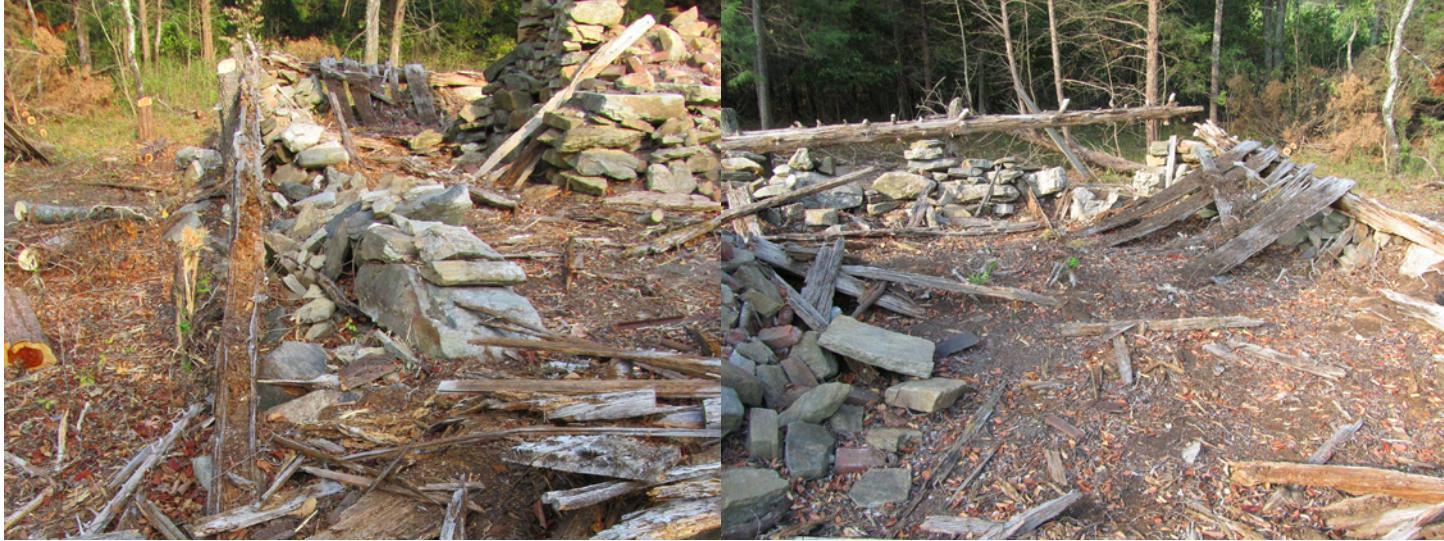
Figure 23. S2, Fearn Slave Quarters Photos.

S2 Fearn Slave Quarters, Aerial View.

S2 Fearn Slave Quarters, Chimney, View to WNW.

S2 Fearn Slave Quarters, South Wall, View to W.

S2 Fearn Slave Quarters, West Half, View to S.

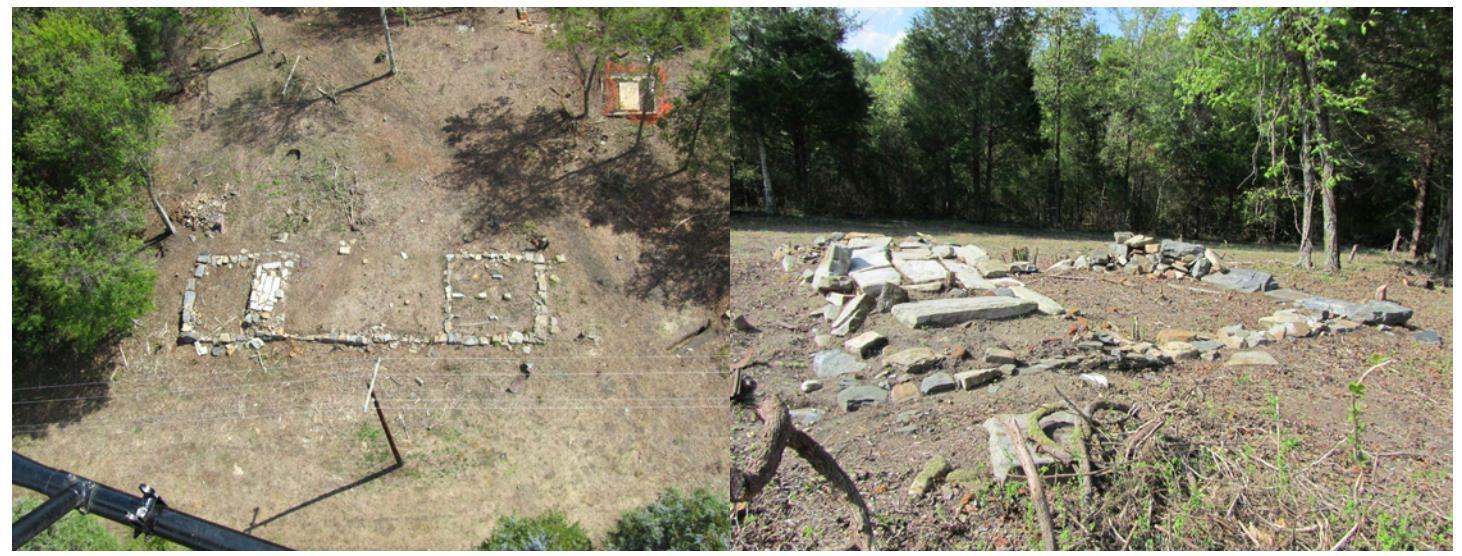
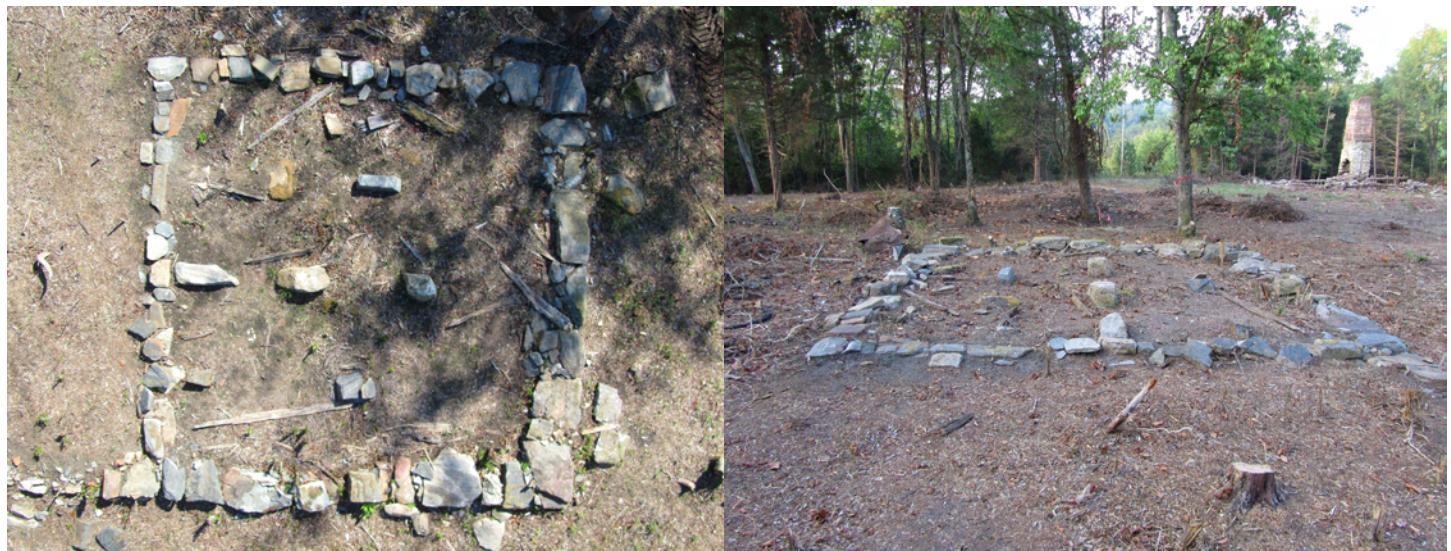
Figure 27, The West Compound Wall Photos, North.

The West Wall Compound Wall Photos, North S4 Kitchen, View to W. S4 Kitchen to left, Shed 1 in middle, S6 Storage/Smokehouse to right. View to E.

Aerial view of S6 Storage/Smokehouse.

S6 Storage/Smokehouse. View to E.

Structure 6 was a 18.5'x17.75' structure with internal regularly set piers and a wooden floor. The exterior walls are dry laid ashlar blocks. The internal piers form a cross set at the center of the walls and converging at the center of the building. Remnants of the wooden flooring were observed. The building characteristics suggest that it was used as a floored and enclosed structure. It might have been used as a storehouse/larder or perhaps as a smokehouse although no evidence of the smoking apparatus was noted.

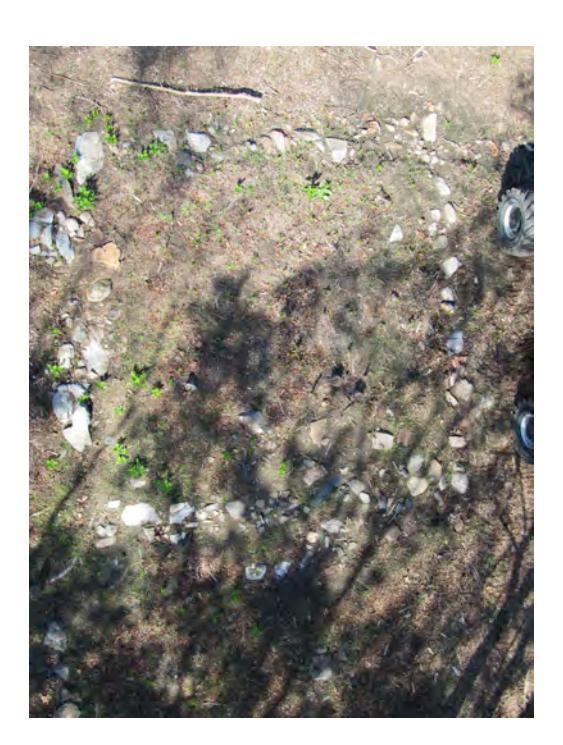
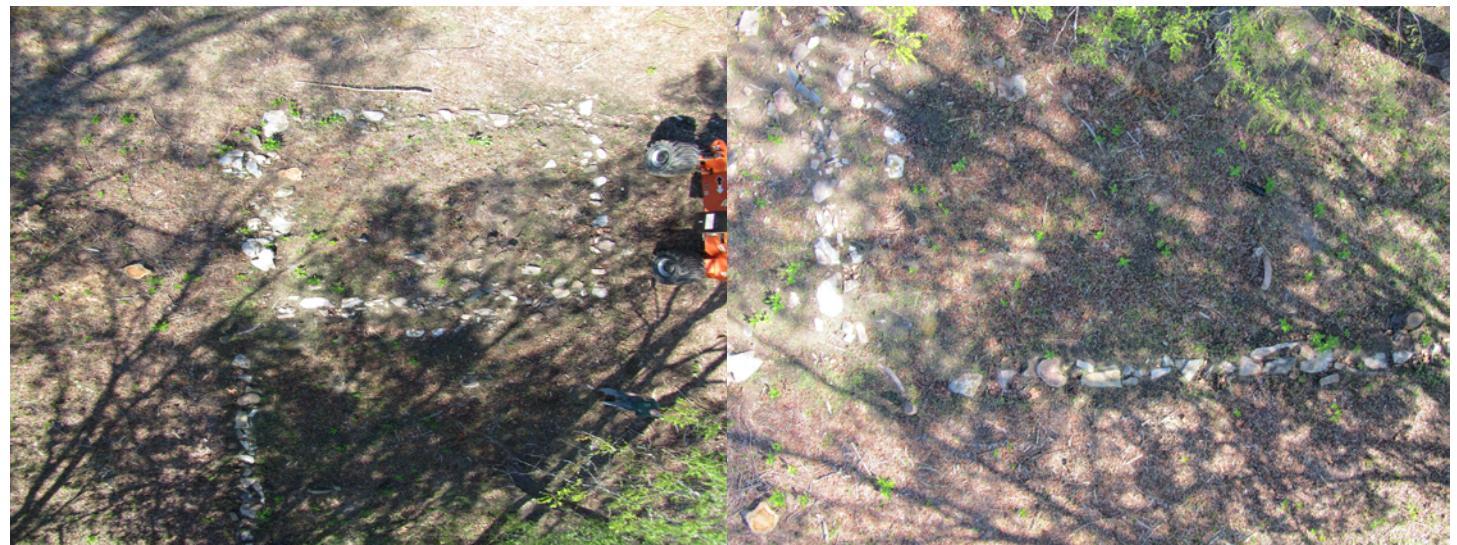
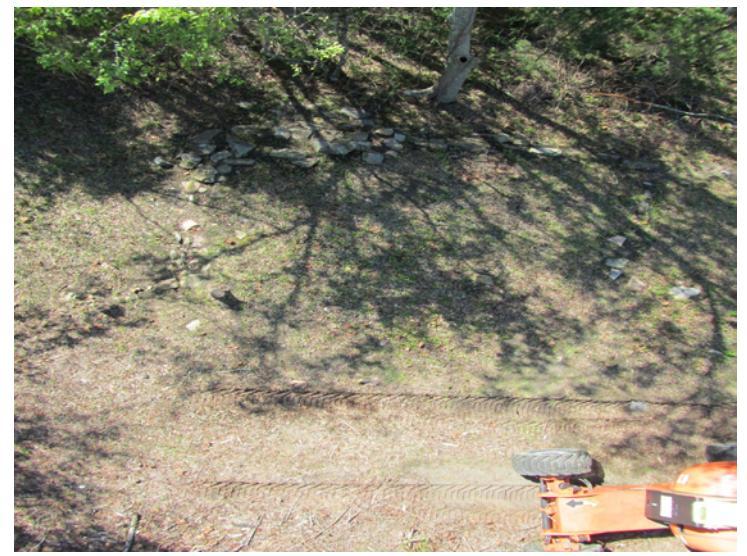
Figure 29. The South Wall S8 Storage 2, S9 Shed & S10 Shed 3 Photos.

S8 Storage, SW Corner Compound, View to W.

S8 Storage E Wall, S9 Shed S. Wall, View to N.

East End, S10 Shed 3, View to S.

Structure 10 is a continuation of the southern wall of the main house compound extended east of Structure 9. The building measures 24.5' x 27.5'. This building has dry laid stone walls on the west, south and east and appears to have been open on the front or north. This building is interpreted as an open fronted storage building, facing north.

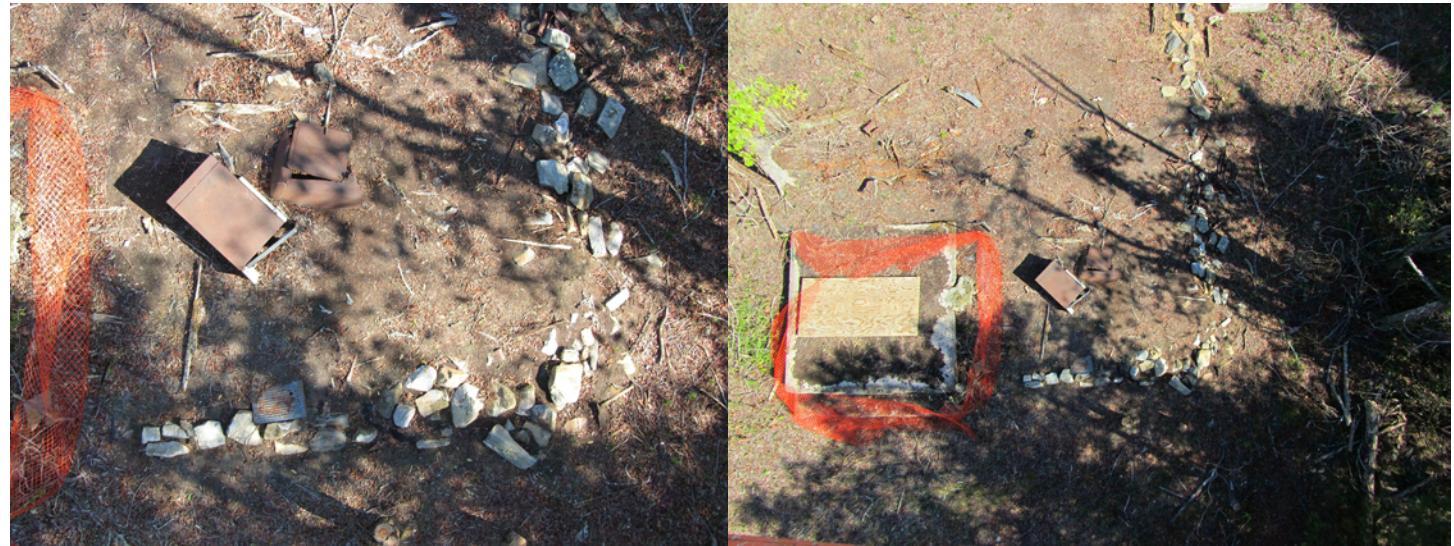
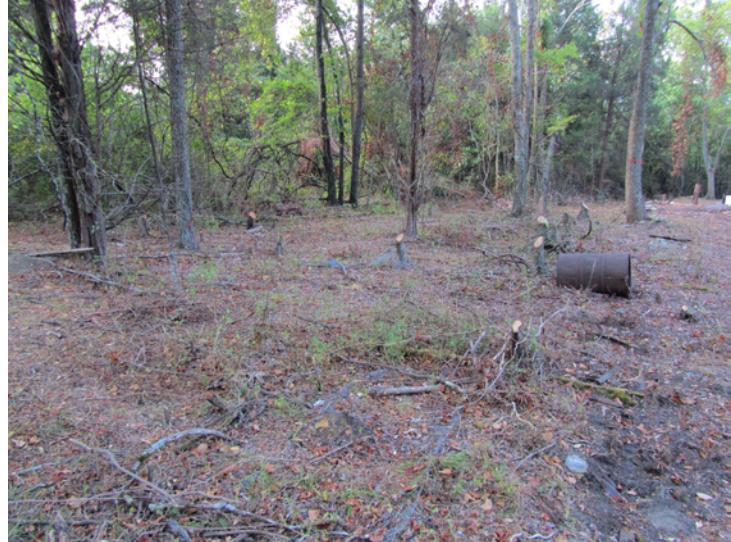
Figure 31. The S11 Well, S12 Shed 4 and S13 Animal Enclosure Photos.

S12, Shed 4, Well Shed with Gas stove, irrigation Equipment. S11 & S12, Aerial View to N. Well is beneath 4x8' Plyboard & Aerial View

S14 Animal Enclosure, note line of saplings to left of barrel and across front of photo.

Structure 14 is an animal enclosure of 38.5' x 23.5'. A combination of saplings along a line of wire fencing showed an "L" shaped enclosure that was largely flat at the time of investigation. This was situated at the back of Structure 12 but was separated from it by a narrow space. The type of animals held in the enclosure is unknown, but the wire mesh size and low height suggests fowl. No evidence of a chicken house was noted but Structure 12 is a possible candidate due to proximity.

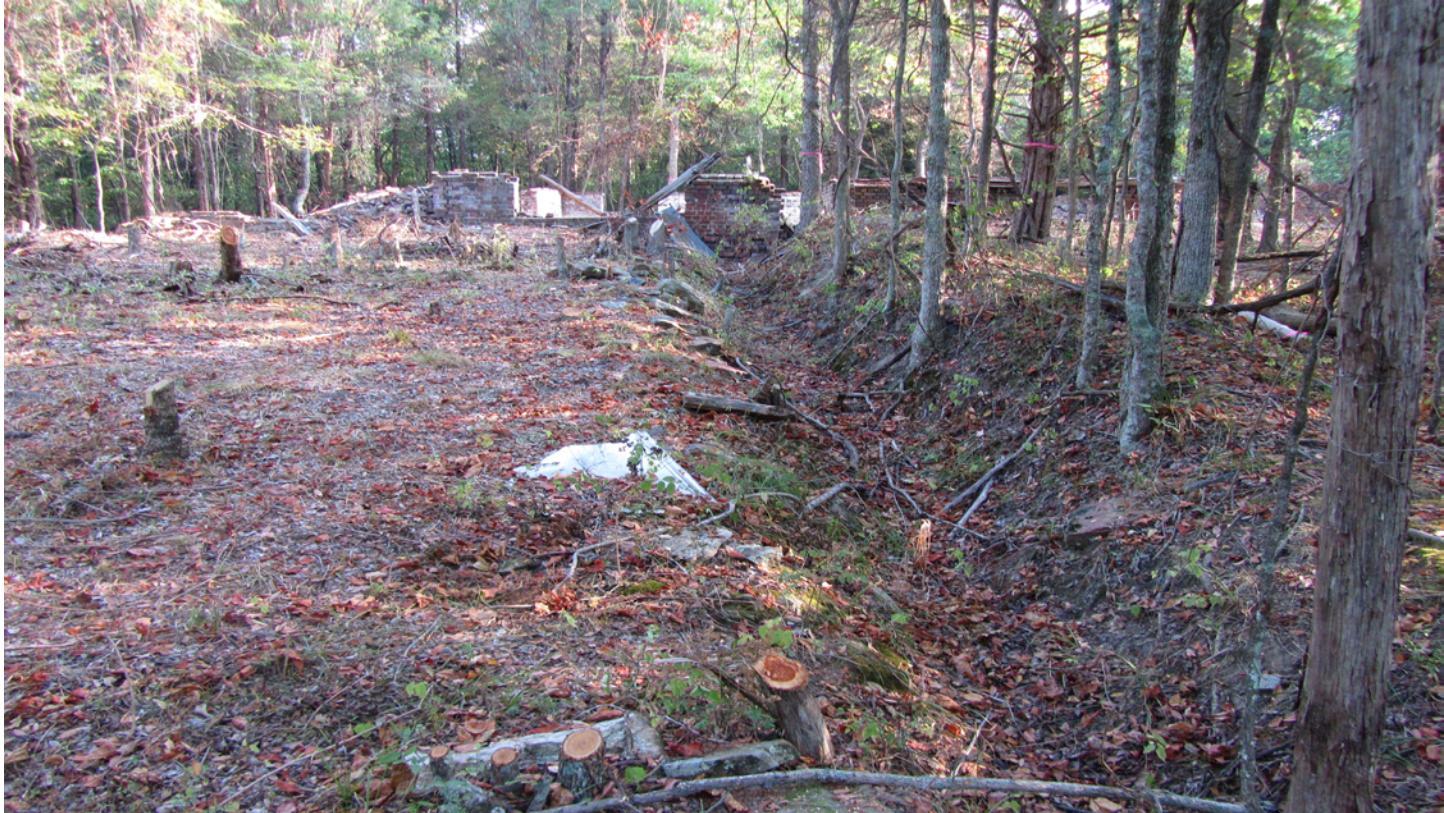
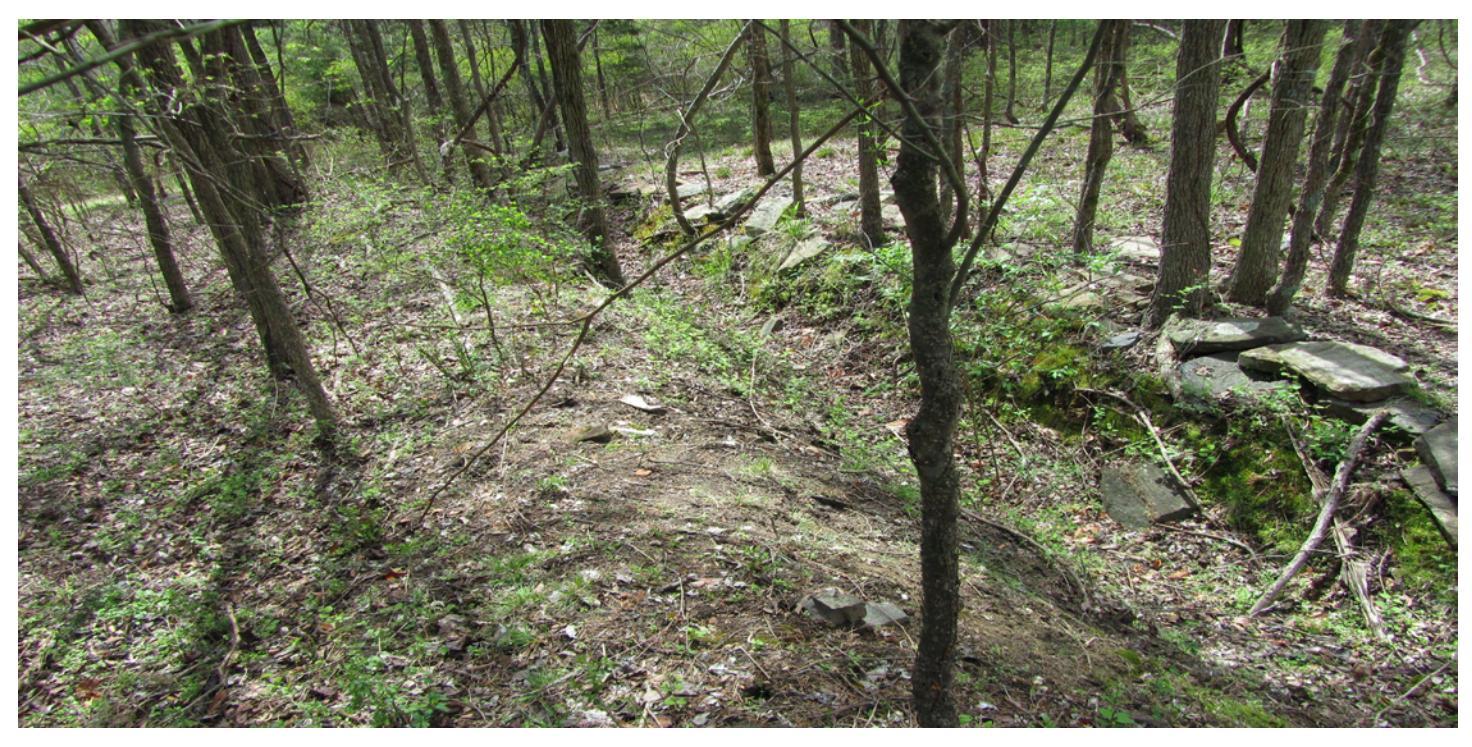
Figure 32. S13 Drainage Ditch, Facing S. Note stones on W side.

S13 Drainage Ditch, Facing N.

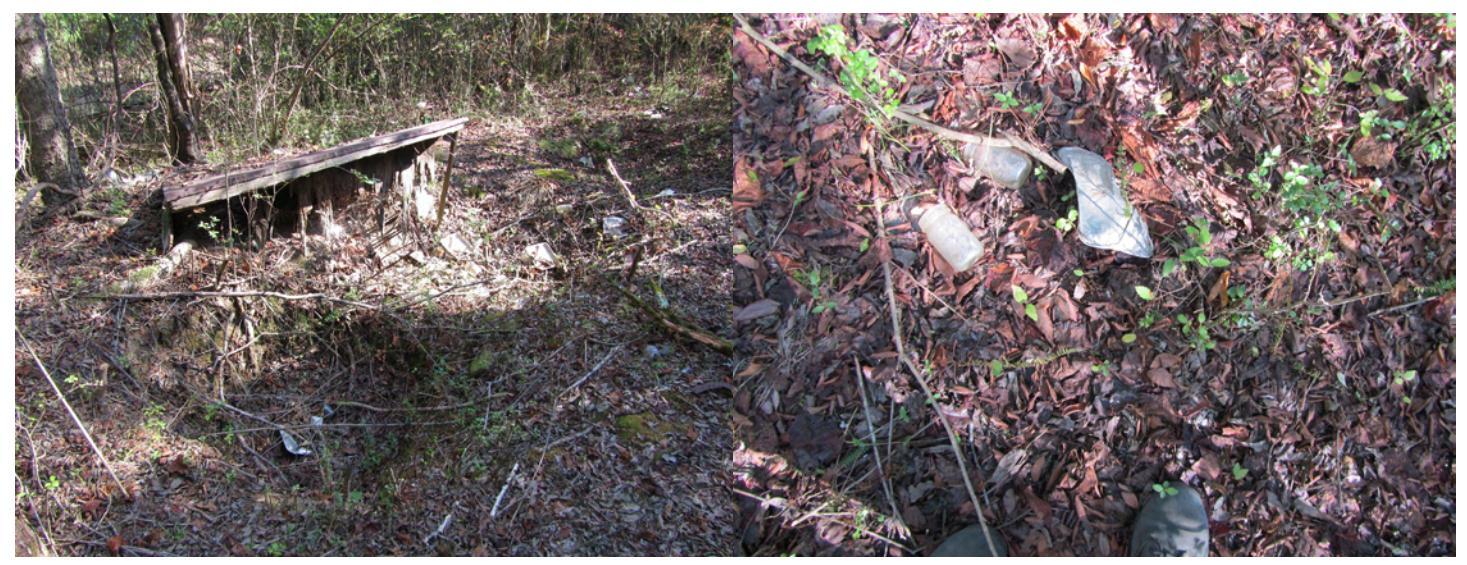
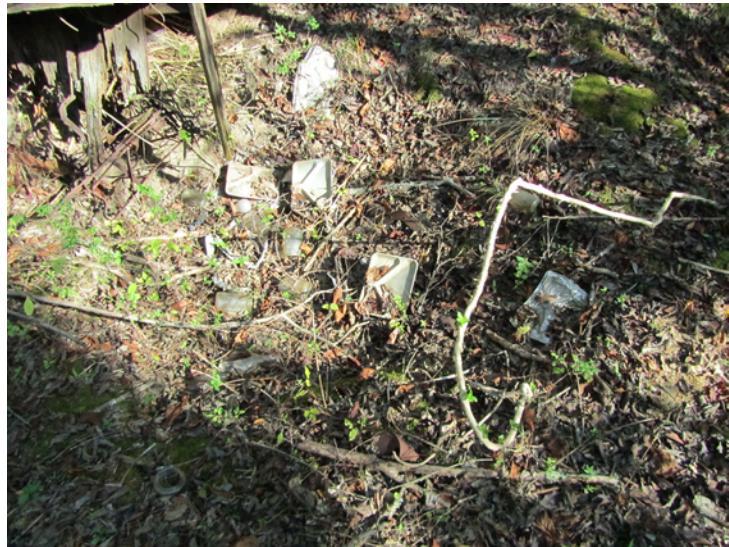
Figure 33. The Privies & Homeless Camp Photos.

C20 Privies, View To W.

C20 Dump Site, Household Refuse.

C20 Dump Site, ? Homeless Camp. Note plastic & aluminum trays.

Structure 15 is a set of three former privies. These are square in shape, set side by side, each about 5 feet across. The remnant of one outhouse has collapsed and decayed approximately halfway into one of them. The construction on the privy building was using dimensional lumber and wire nails, indicating a 20th century date.

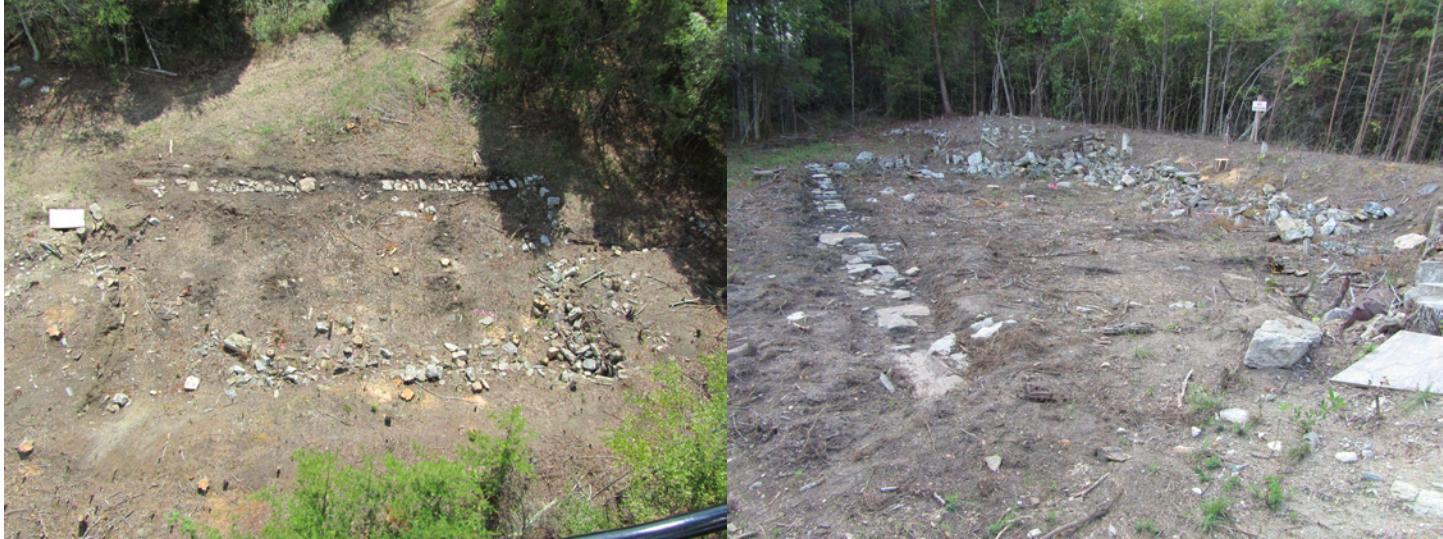
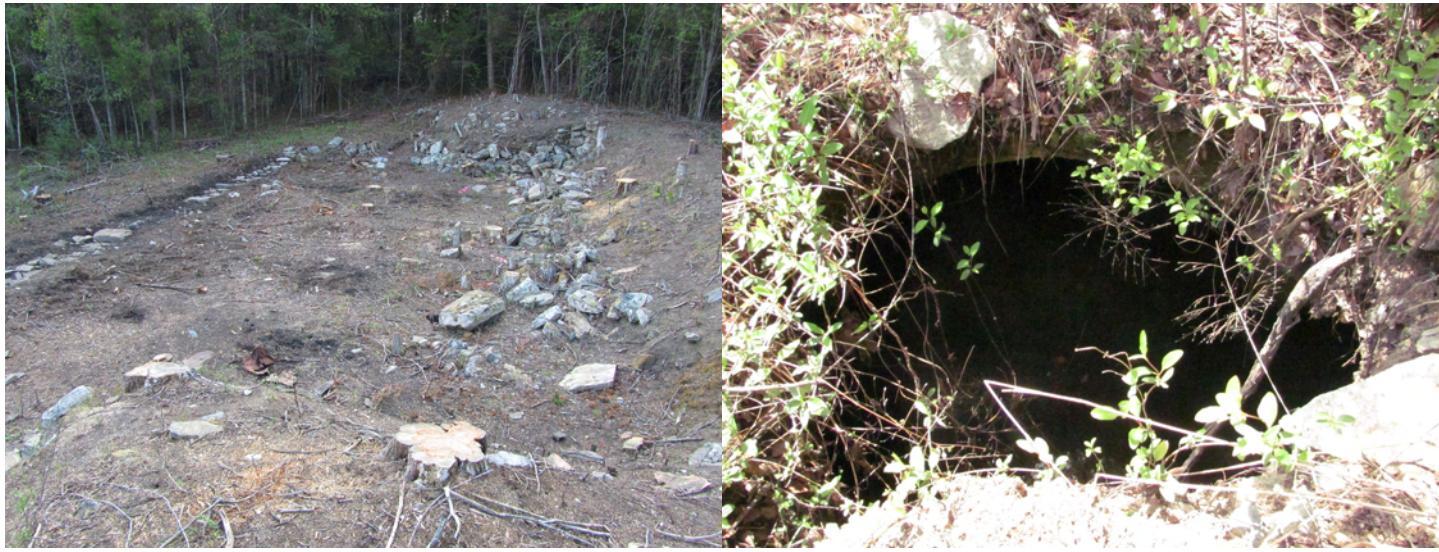
Figure 35. The S17 Barn & S18 Cistern Photos.

S17 Barn, Facing South.

S17 Barn, Facing West.

S17 Barn, Facing WSW.

S18 Cistern, Facing N.

As the barn was not extant on the 1954 aerial photo and was known to have burned in 1900 (Walters 2012). The complete destruction of the 1900 crop year's worth of harvest would also indicate that the granary was affected, assuming separate functions for the barn and the granary. The barn is typically used for animal shelter at the bottom, hay storage on the upper ground floor accessed from the bank and for any additional floors on the interior. Normally, barns are more or less open on the interior to allow for movement of hay inside. Loose hay was the norm until hay balers appeared. The typical barn had a hay fork that moved loose hay from wagons into the barn for storage for winter fodder. Barns also usually had a small granary for animal feed purposes occupying part of one bay of the barn. But, the dynamics of how a barn interacted with a granary on a large plantation operation are poorly known. On *a priori* grounds, the barn would hold hay while the granary would be a rodent-proofed structure designed to hold bagged or bulk harvested grain.

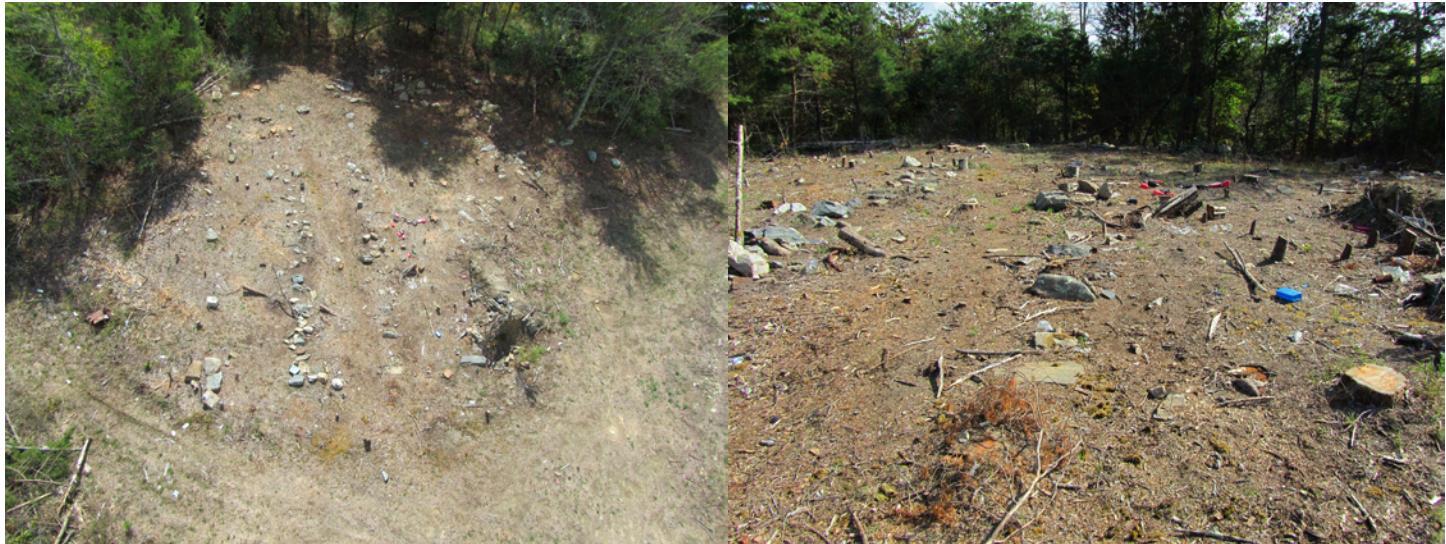
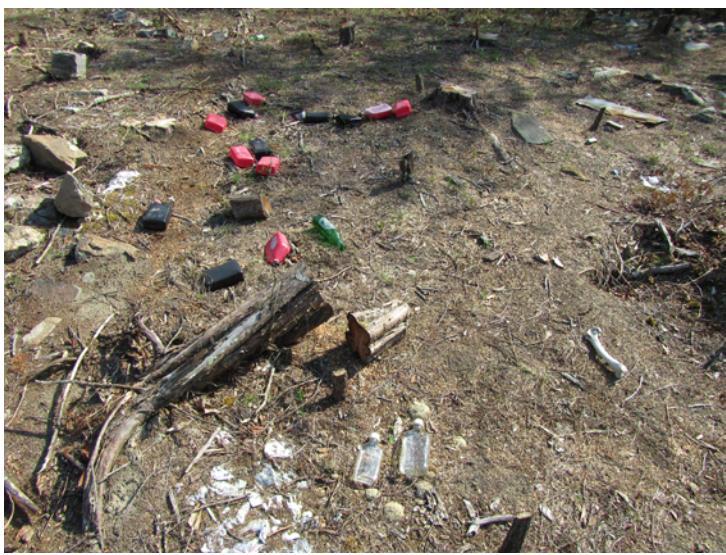
Figure 35. The S19 Granary & S20 Staging Area Photos.

S19 Granary, Facing South.

S20 Staging Area.

Structure 20 appeared to be a staging area for the logging company that harvested the timber about 15 years ago. The materials consisted of plastic beverage bottles, including cans as well as 2 liter plastic bottles, snack containers and plastic quart oil containers. Not noted were old oil filters or areas where oil had been drained directly on the ground, although the latter might have dissipated in the interim. This set of artifacts occupied about half of the area of the granary. It would have dated to after 1972 when the buildings were dismantled.

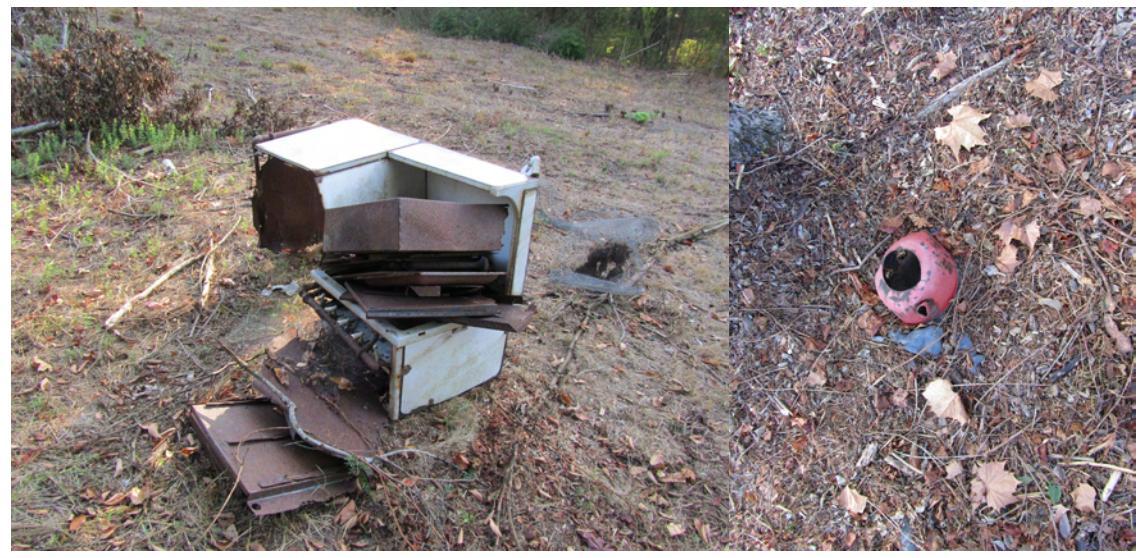
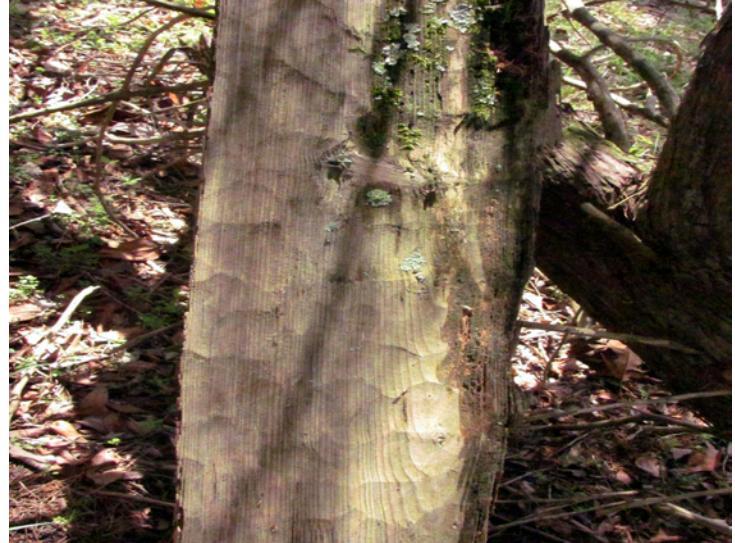
Figure 38. The Surface Artifact Photos.

Gas Stove, Adjacent to Slave Quarters.

Red Tin-Enameled Teapot, Main House Compound.

Slave Quarters Floor Board, Adzed.
